RCA-03-007 Rev 1

**ADVANCED MIXED WASTE TREATMENT PROJECT**

**Investigation and Root Cause Analysis  
of the  
Fire in the TRU Waste Drum**

**BNFL INC.**

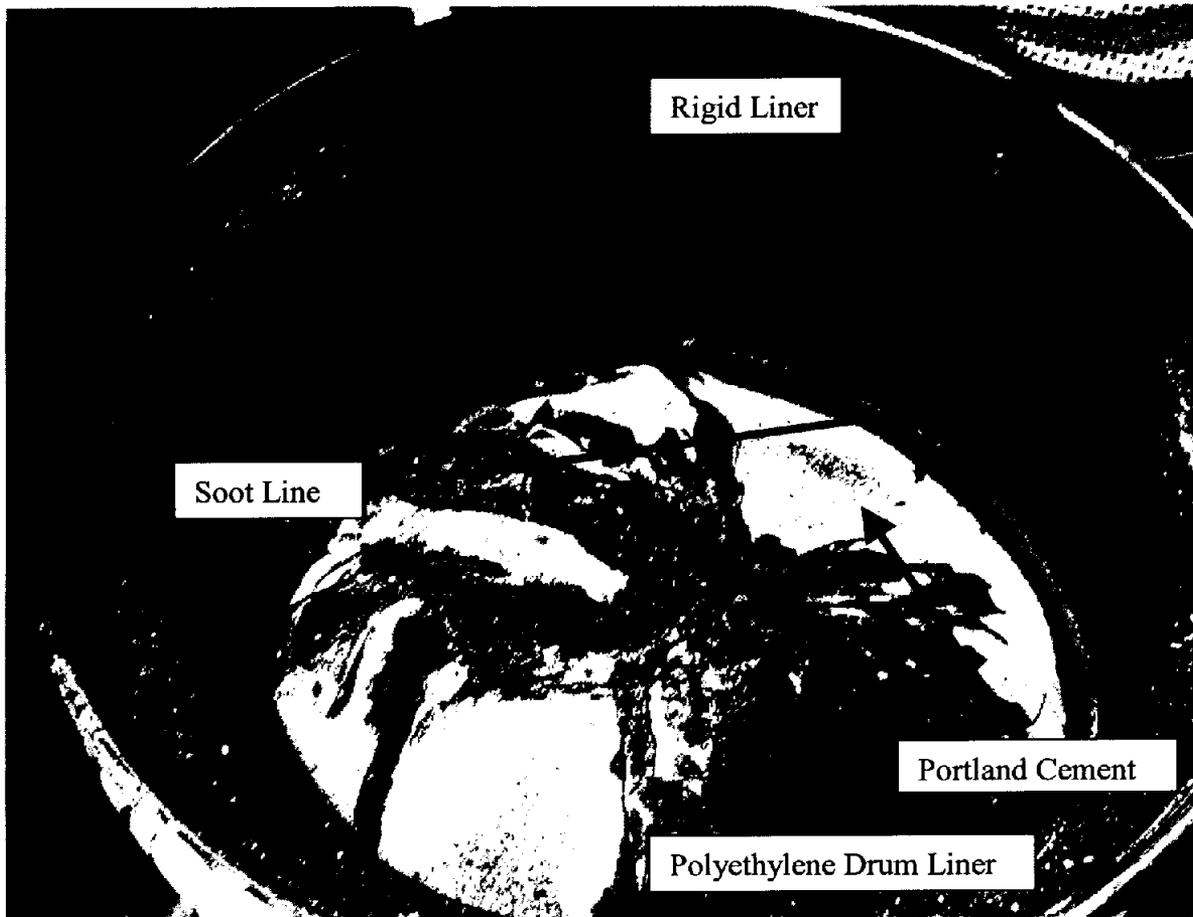
A smoke soot line was visibly evident and was limited to the headspace volume of the drum (Photograph 7). The top of the waste drum polyethylene drum liner (plastic bag) used to line the drum had burned, decomposed, and melted exposing the layer of Portland cement used to cover the sludge-bearing waste material. The configuration of the solidified waste appeared to be unaffected. Based on the soot line markings, polyethylene drum liner (plastic bag) damage, and the absence of external drum contamination, it was concluded that the fire primarily occurred in the drum headspace and did not involve any of the radiological waste material.

**Photograph 7:** Interior of the drum following the fire, showing the soot line about 12 inches below the rim of the drum.

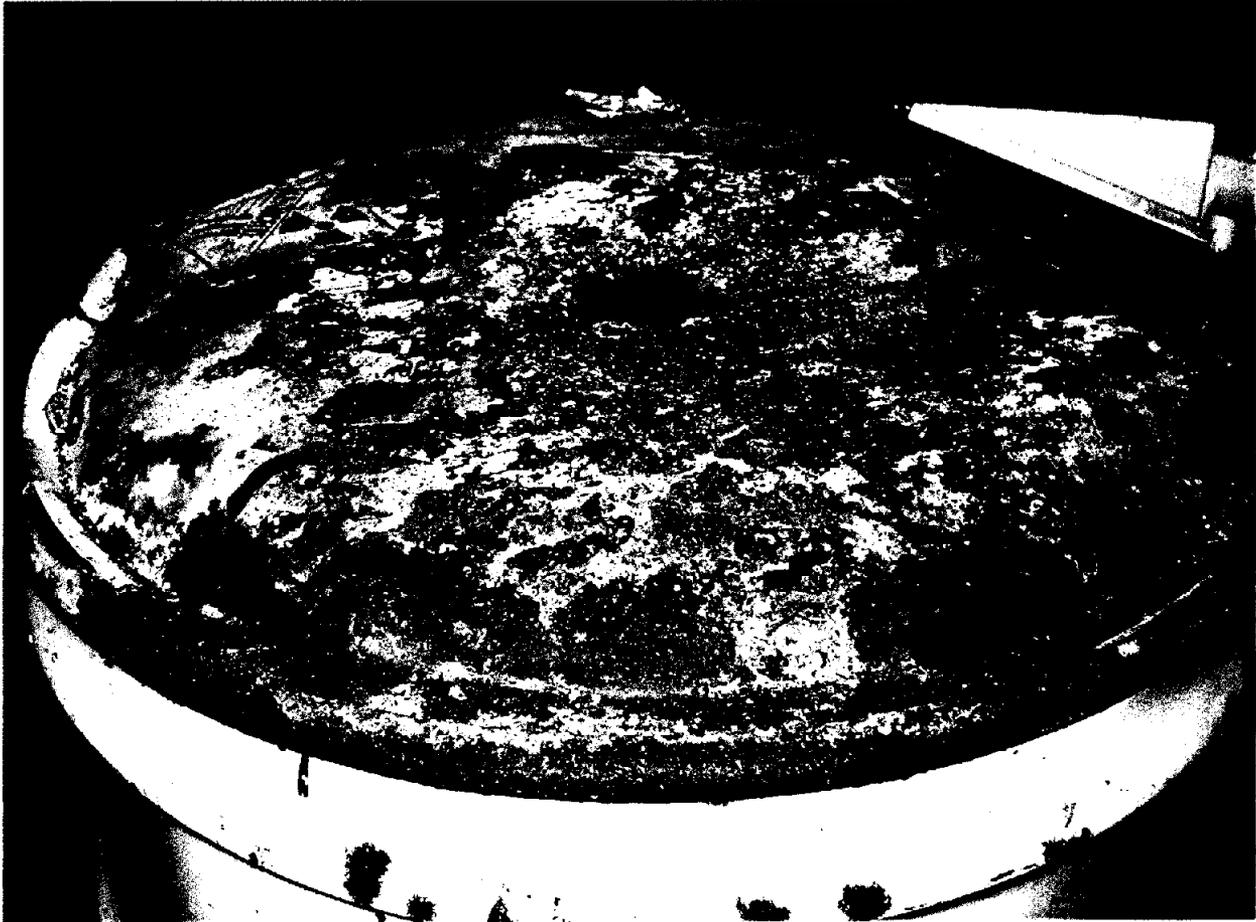
**Photograph 3:** Drum lid post-event, prior to removal, showing bulging.

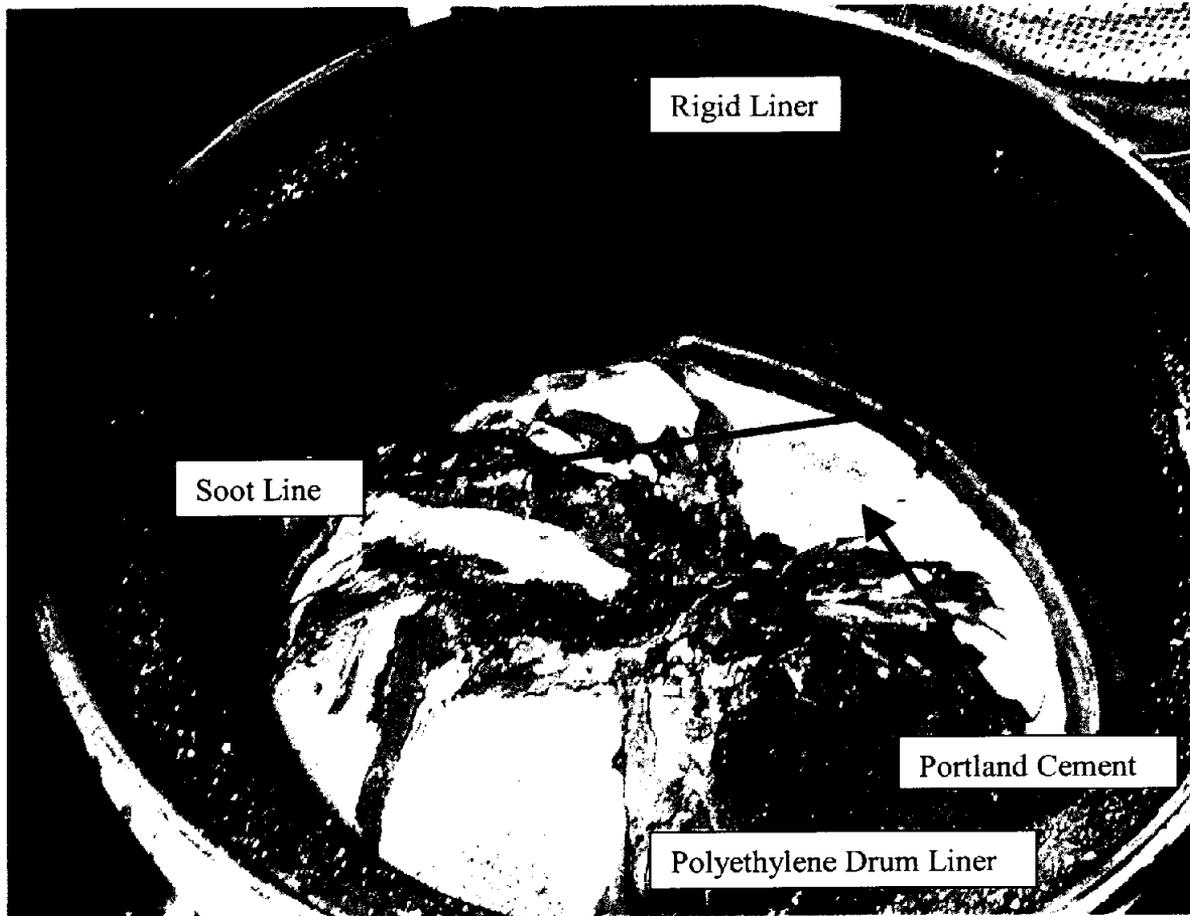
**Photograph 7:** Interior of the drum following the fire, showing the soot line about 12 inches below the rim of the drum.
