RCA-03-007 Rev 1

**ADVANCED MIXED WASTE TREATMENT PROJECT**

**Investigation and Root Cause Analysis  
of the  
Fire in the TRU Waste Drum**

**BNFL INC.**

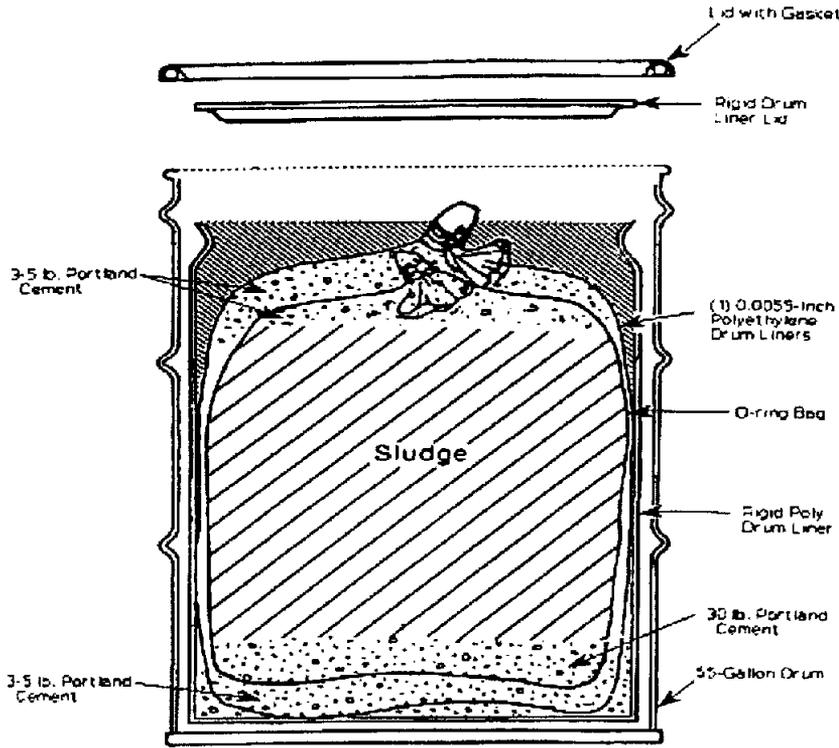
Drum IDRF07411511 was configured similar to that shown in Figure 2. The drum was originally filled at Rocky Flats by first placing a rigid poly drum liner in the 55-gallon steel drum. Then, dry Portland cement was added to the bottom of the rigid poly drum liner. Next, a flexible polyethylene drum liner (plastic bag) was placed into the rigid poly drum. Dry Portland cement was added to the bottom of this liner. Next, another polyethylene drum liner (plastic bag) was placed in the barrel and the sludge placed into it. Once the drum was about 75% full, the inner polyethylene drum liner (plastic bag) was twisted closed and sealed with tape. Additional dry Portland cement was placed on top of the sludge bag and then the outer polyethylene drum liner (plastic bag) was twisted closed and taped. Next, the rigid drum liner lid was placed on the rigid drum liner in the drum. Finally, the metal drum lid was placed on the drum using a gasket and a sealing ring to seal the drum. The purpose of adding the Portland cement was to bind up any free liquid that may be released during storage and to harden the material within the drum. At the time of the event the drum contained no free liquids.

**Figure 2:** Typical packaging for drums with IDC Code D001, like the one involved in the event (Wastren, 1995).

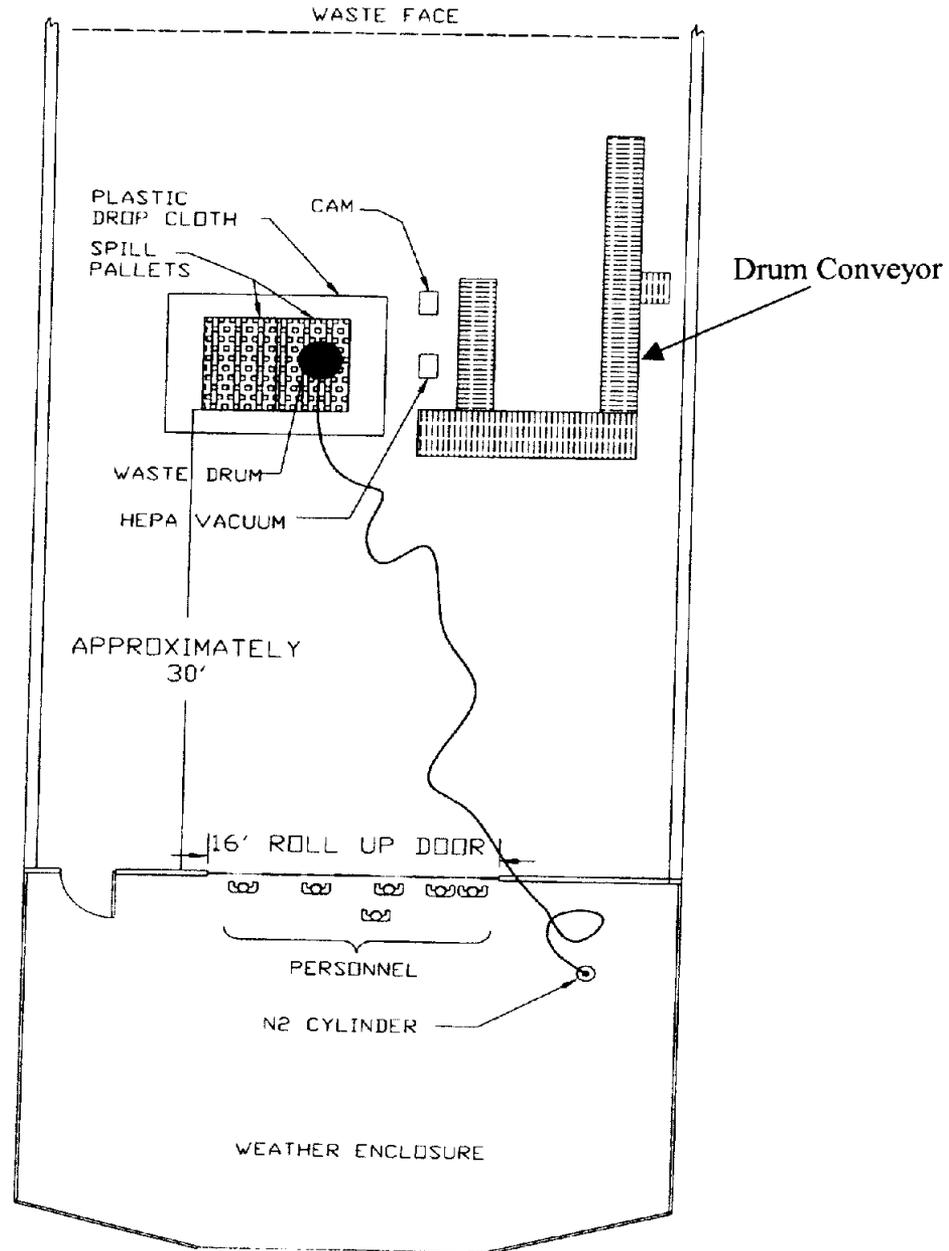
The spill pallet was positioned on a plastic sheet that was placed on the dirt floor that covers most of that portion of the TSA-RE (Figure 3 and Photograph 2). Preoperational checks of the venting equipment were performed, as delineated in procedure INST-OI-09. Once the drum was ready for venting, personnel moved outside the TSA-RE to the weather enclosure, closed the rollup door, and began the venting process. During the event, one individual was reading the procedure steps and another was repeating the instruction prior to performing the actions.

**Figure 3:** Plan view representing the configuration of the Remote Drum Punch equipment and personnel locations relative to the waste drum in WMF-636.

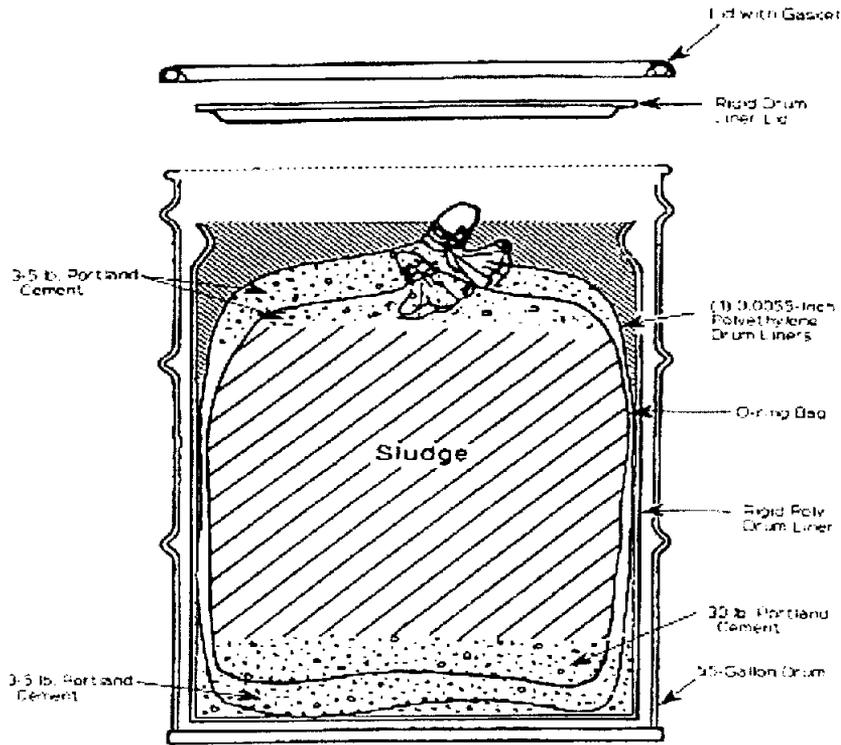
Drum IDR07411511 was configured similar to that shown in Figure 2. The drum was originally filled at Rocky Flats by first placing a rigid poly drum liner in the 55-gallon steel drum. Then, dry Portland cement was added to the bottom of the rigid poly drum liner. Next, a flexible polyethylene drum liner (plastic bag) was placed into the rigid poly drum. Dry Portland cement was added to the bottom of this liner. Next, another polyethylene drum liner (plastic bag) was placed in the barrel and the sludge placed into it. Once the drum was about 75% full, the inner polyethylene drum liner (plastic bag) was twisted closed and sealed with tape. Additional dry Portland cement was placed on top of the sludge bag and then the outer polyethylene drum liner (plastic bag) was twisted closed and taped. Next, the rigid drum liner lid was placed on the rigid drum liner in the drum. Finally, the metal drum lid was placed on the drum using a gasket and a sealing ring to seal the drum. The purpose of adding the Portland cement was to bind up any free liquid that may be released during storage and to harden the material within the drum. At the time of the event the drum contained no free liquids.

**Figure 2:** Typical packaging for drums with IDC Code D001, like the one involved in the event (Wastren, 1995).

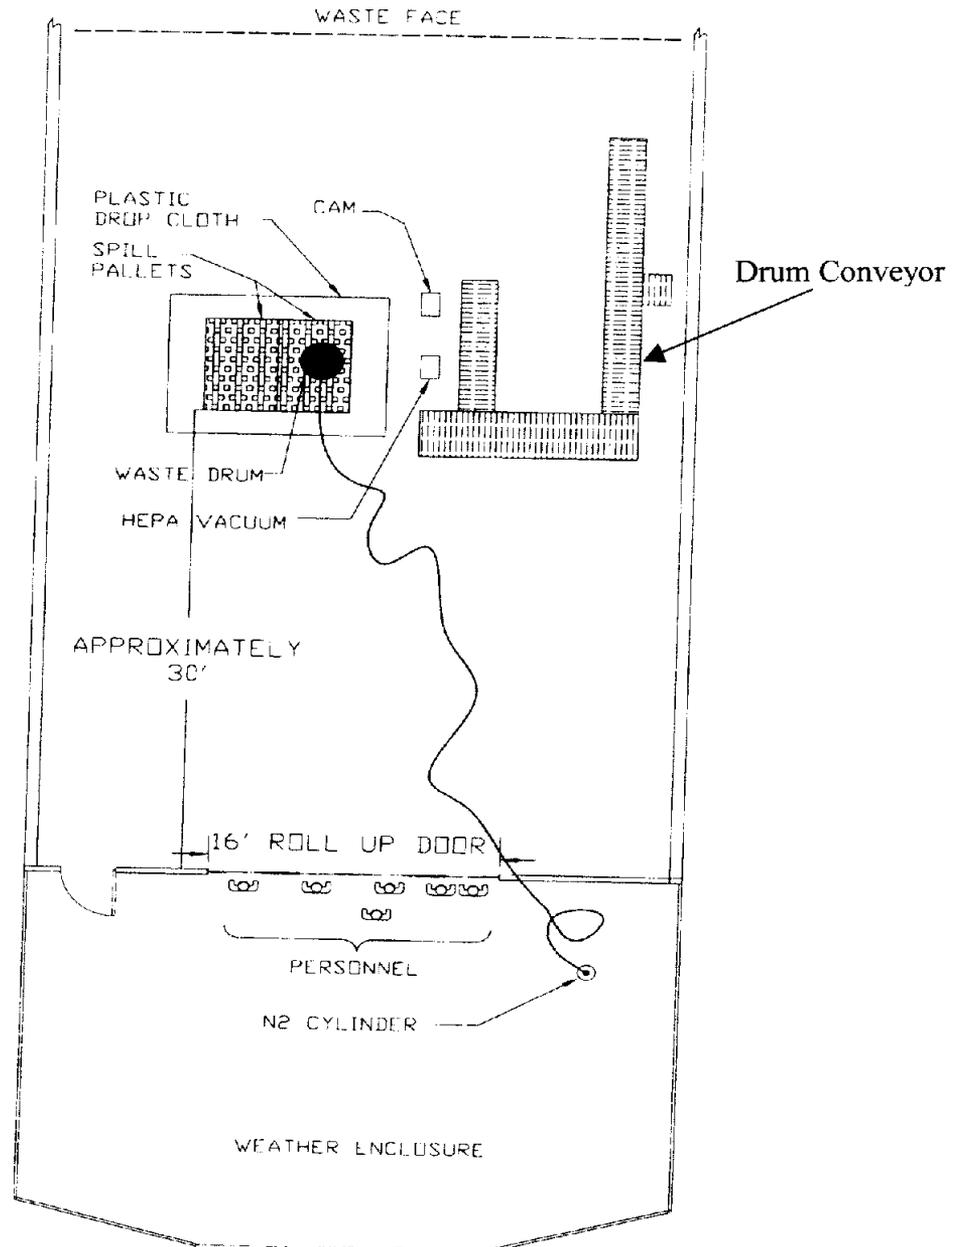
The spill pallet was positioned on a plastic sheet that was placed on the dirt floor that covers most of that portion of the TSA-RE (Figure 3 and Photograph 2). Preoperational checks of the venting equipment were performed, as delineated in procedure INST-OI-09. Once the drum was ready for venting, personnel moved outside the TSA-RE to the weather enclosure, closed the rollup door, and began the venting process. During the event, one individual was reading the procedure steps and another was repeating the instruction prior to performing the actions.

**Figure 3:** Plan view representing the configuration of the Remote Drum Punch equipment and personnel locations relative to the waste drum in WMF-636.

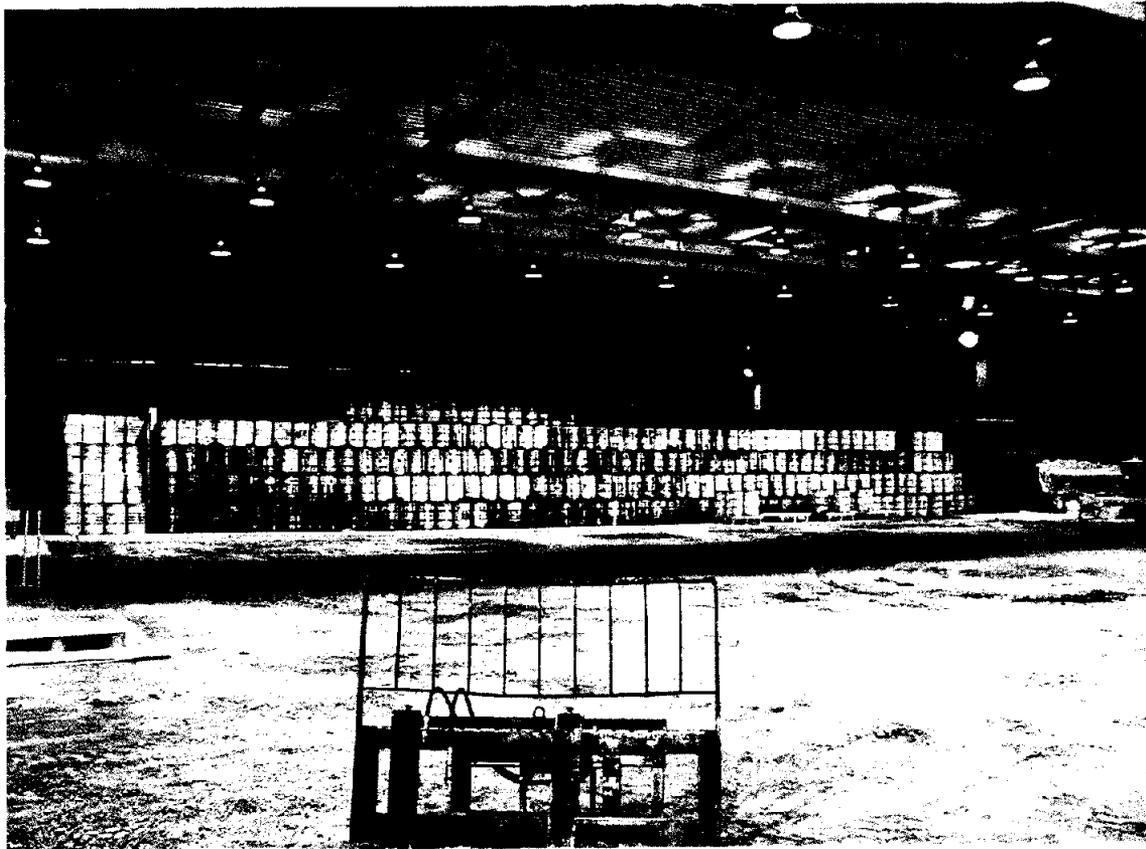
The overall goal of the AMWTP is to prepare approximately 115,000 55-gallon drums and another 10,000 of other types of containers containing TRU mixed waste that is stored in various buildings on the RWMC site. The waste is retrieved from the current storage locations at the site. The contents of the containers are characterized so they can be certified for shipment to another site for long-term storage. This event took place at one of the site's storage buildings, the Transuranic Storage Area – Retrieval Enclosure (TSA-RE), also known as Building WMF-636 (Photograph 1), during the venting of the drum.

**Photograph 1:** Interior of the Transuranic Storage Area – Retrieval Area; the drum being vented during this event was off to the right of this picture.
